CONCESSION SOUTH OF MALDEN ROAD - LOT 18

GASOLINE CONTAMINATION OF A PRIVATE WELL

J. P. Phimister

1973

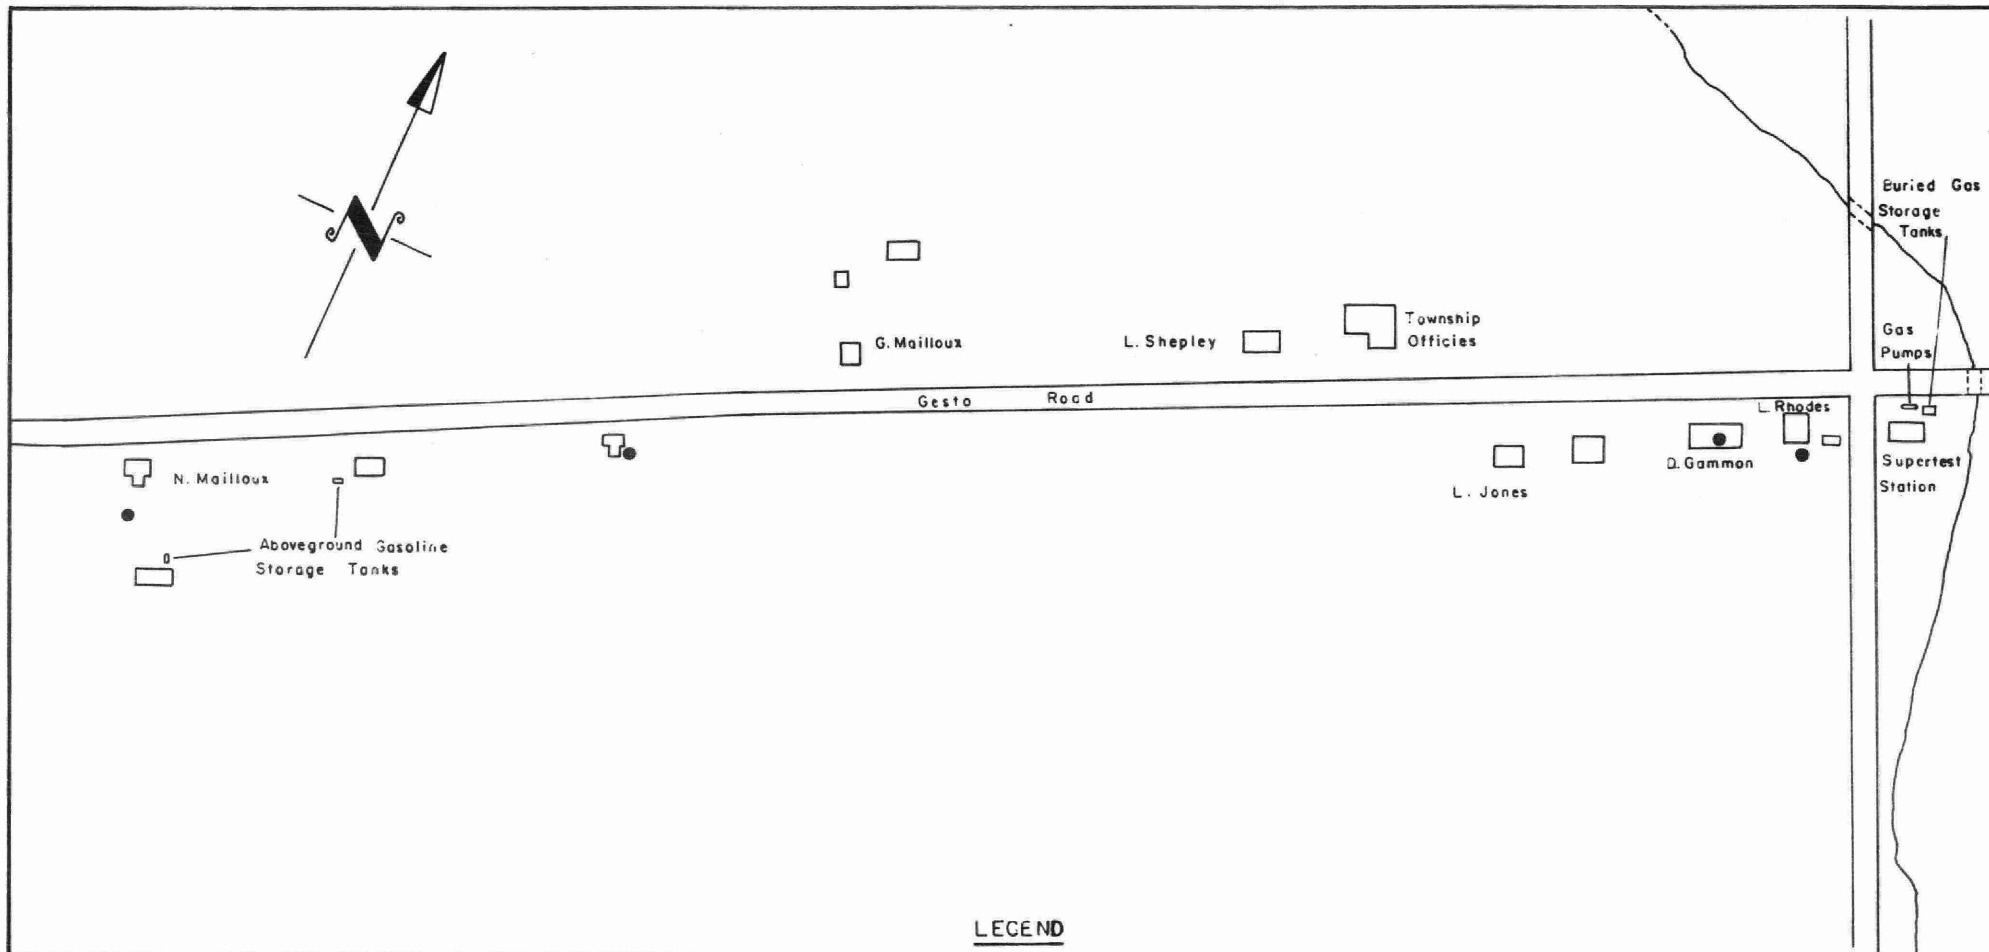
Drawing No:  
FIGURE 1

Figure 1 is a map showing the location of the residences and wells in the vicinity of Gesto and the N. Mailloux property. The locations of some of the gasoline tanks in the area are also shown.
